Case 362 : Narrative

Case Vehicle (A): 1998 Chevrolet
Type: Venture, Sport van
Driver: 35-year-old female
CDC: 12-FZEW-4

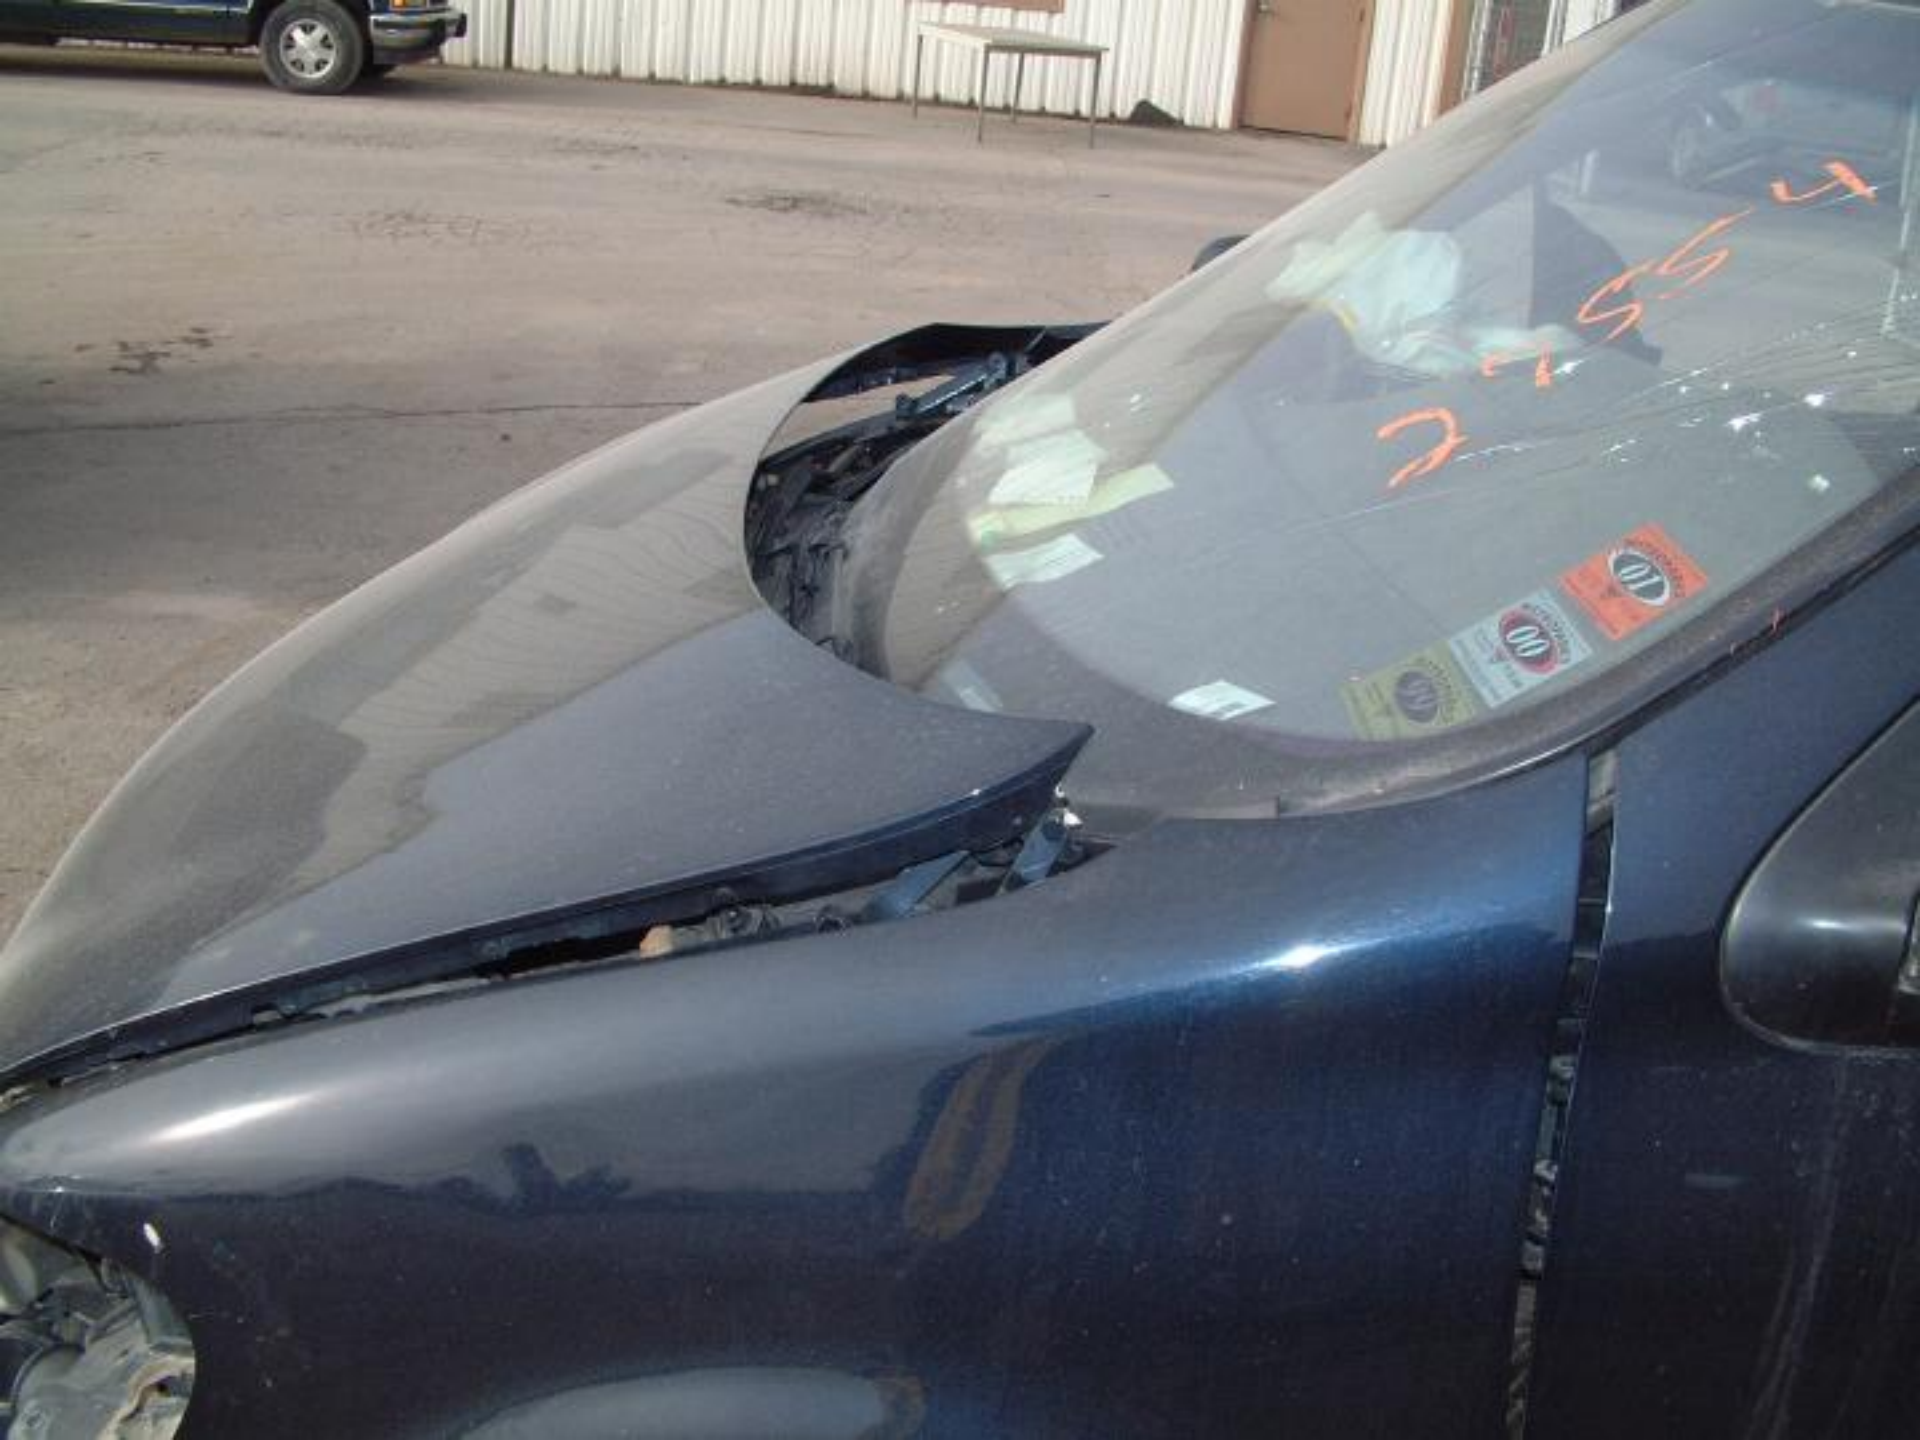
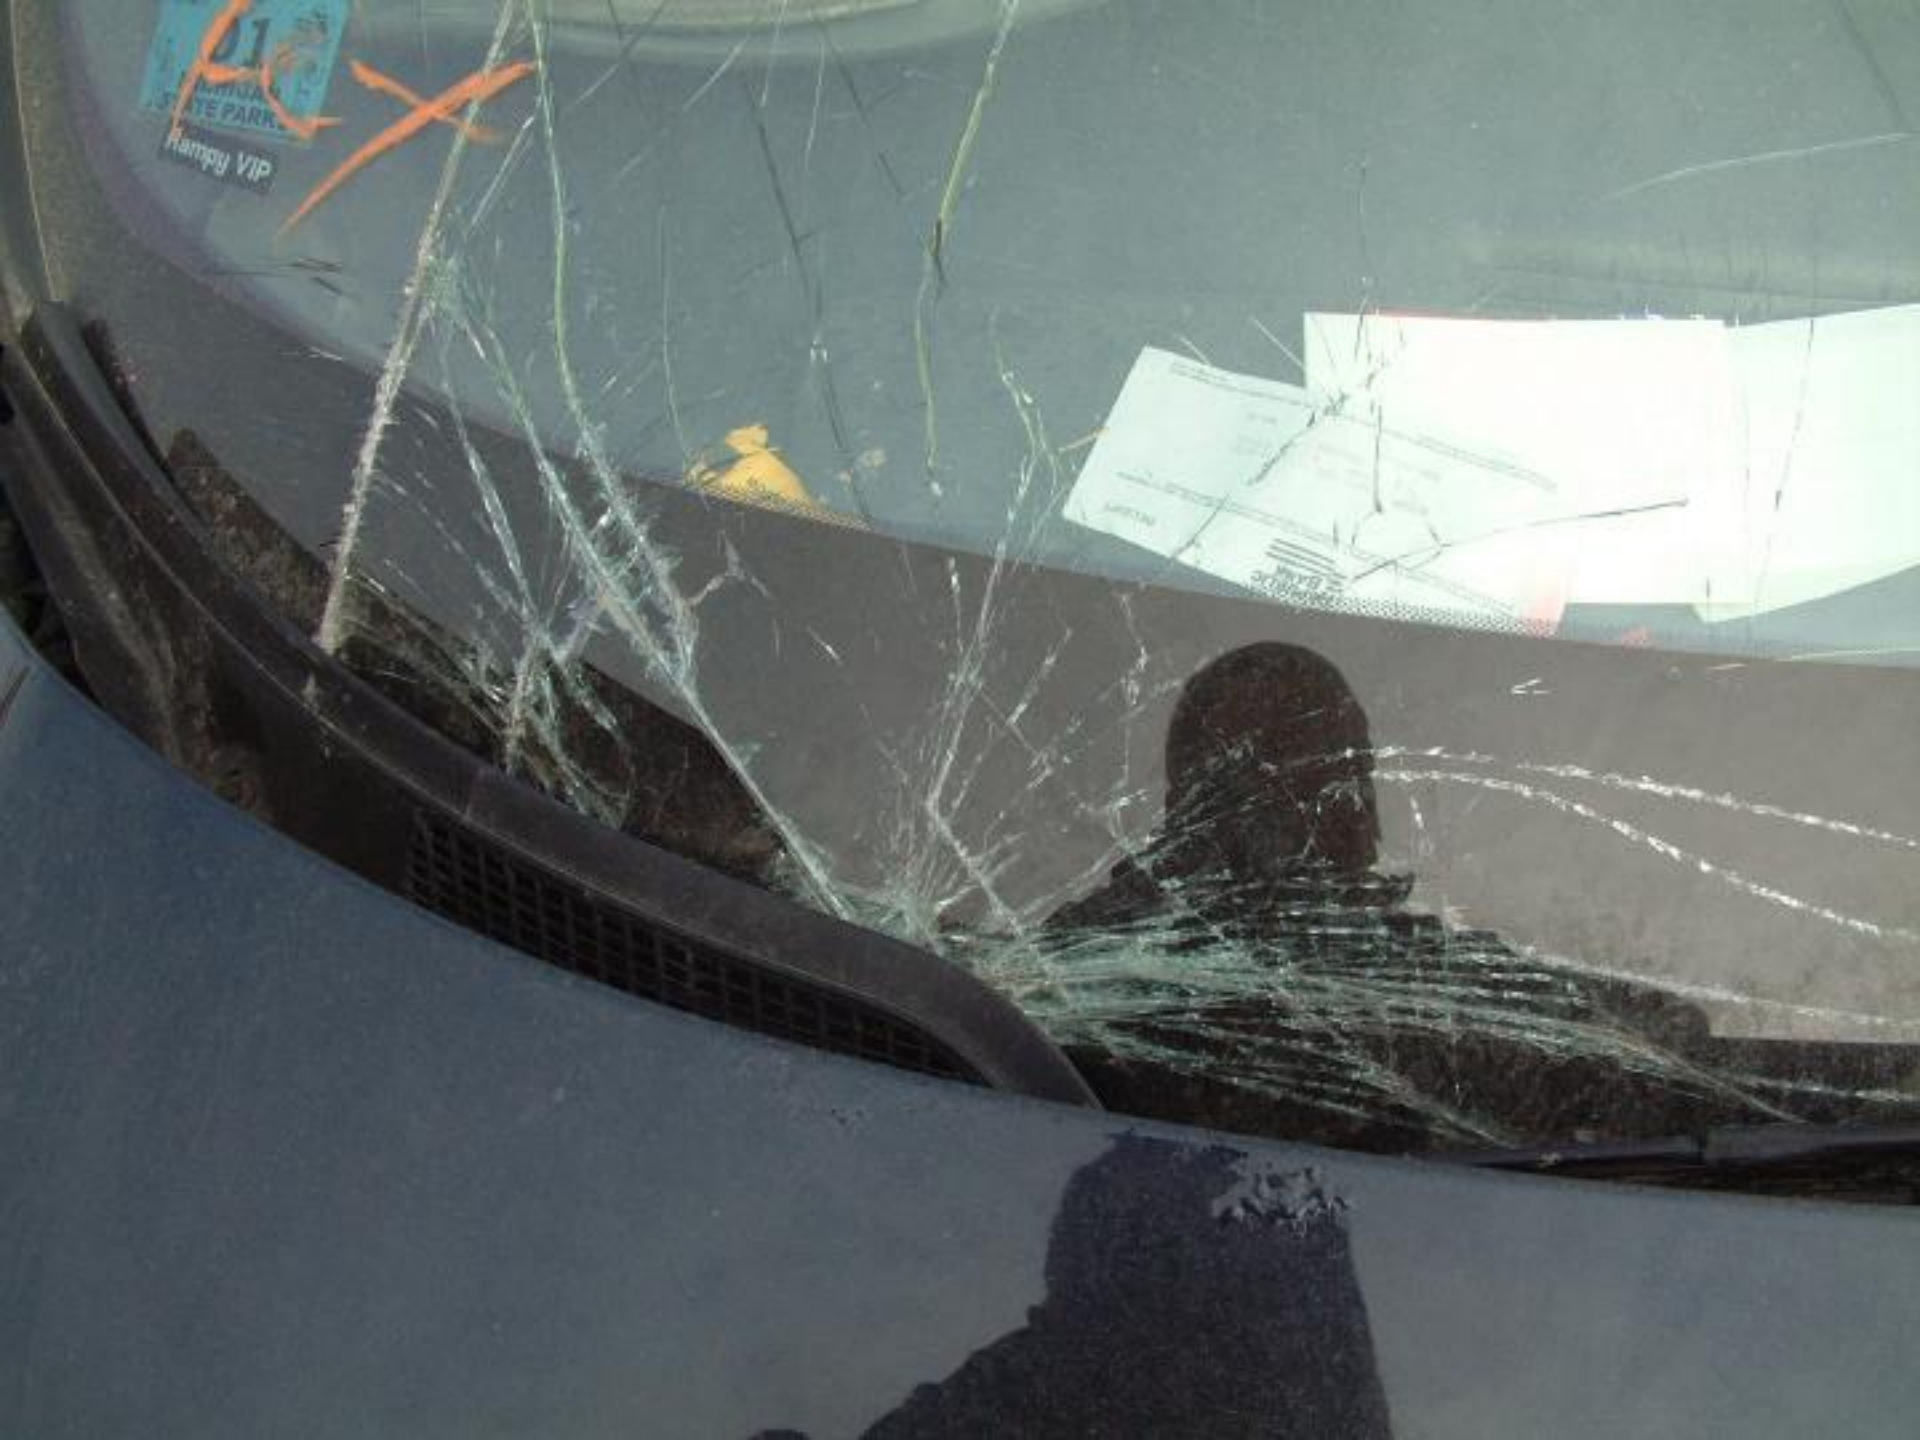
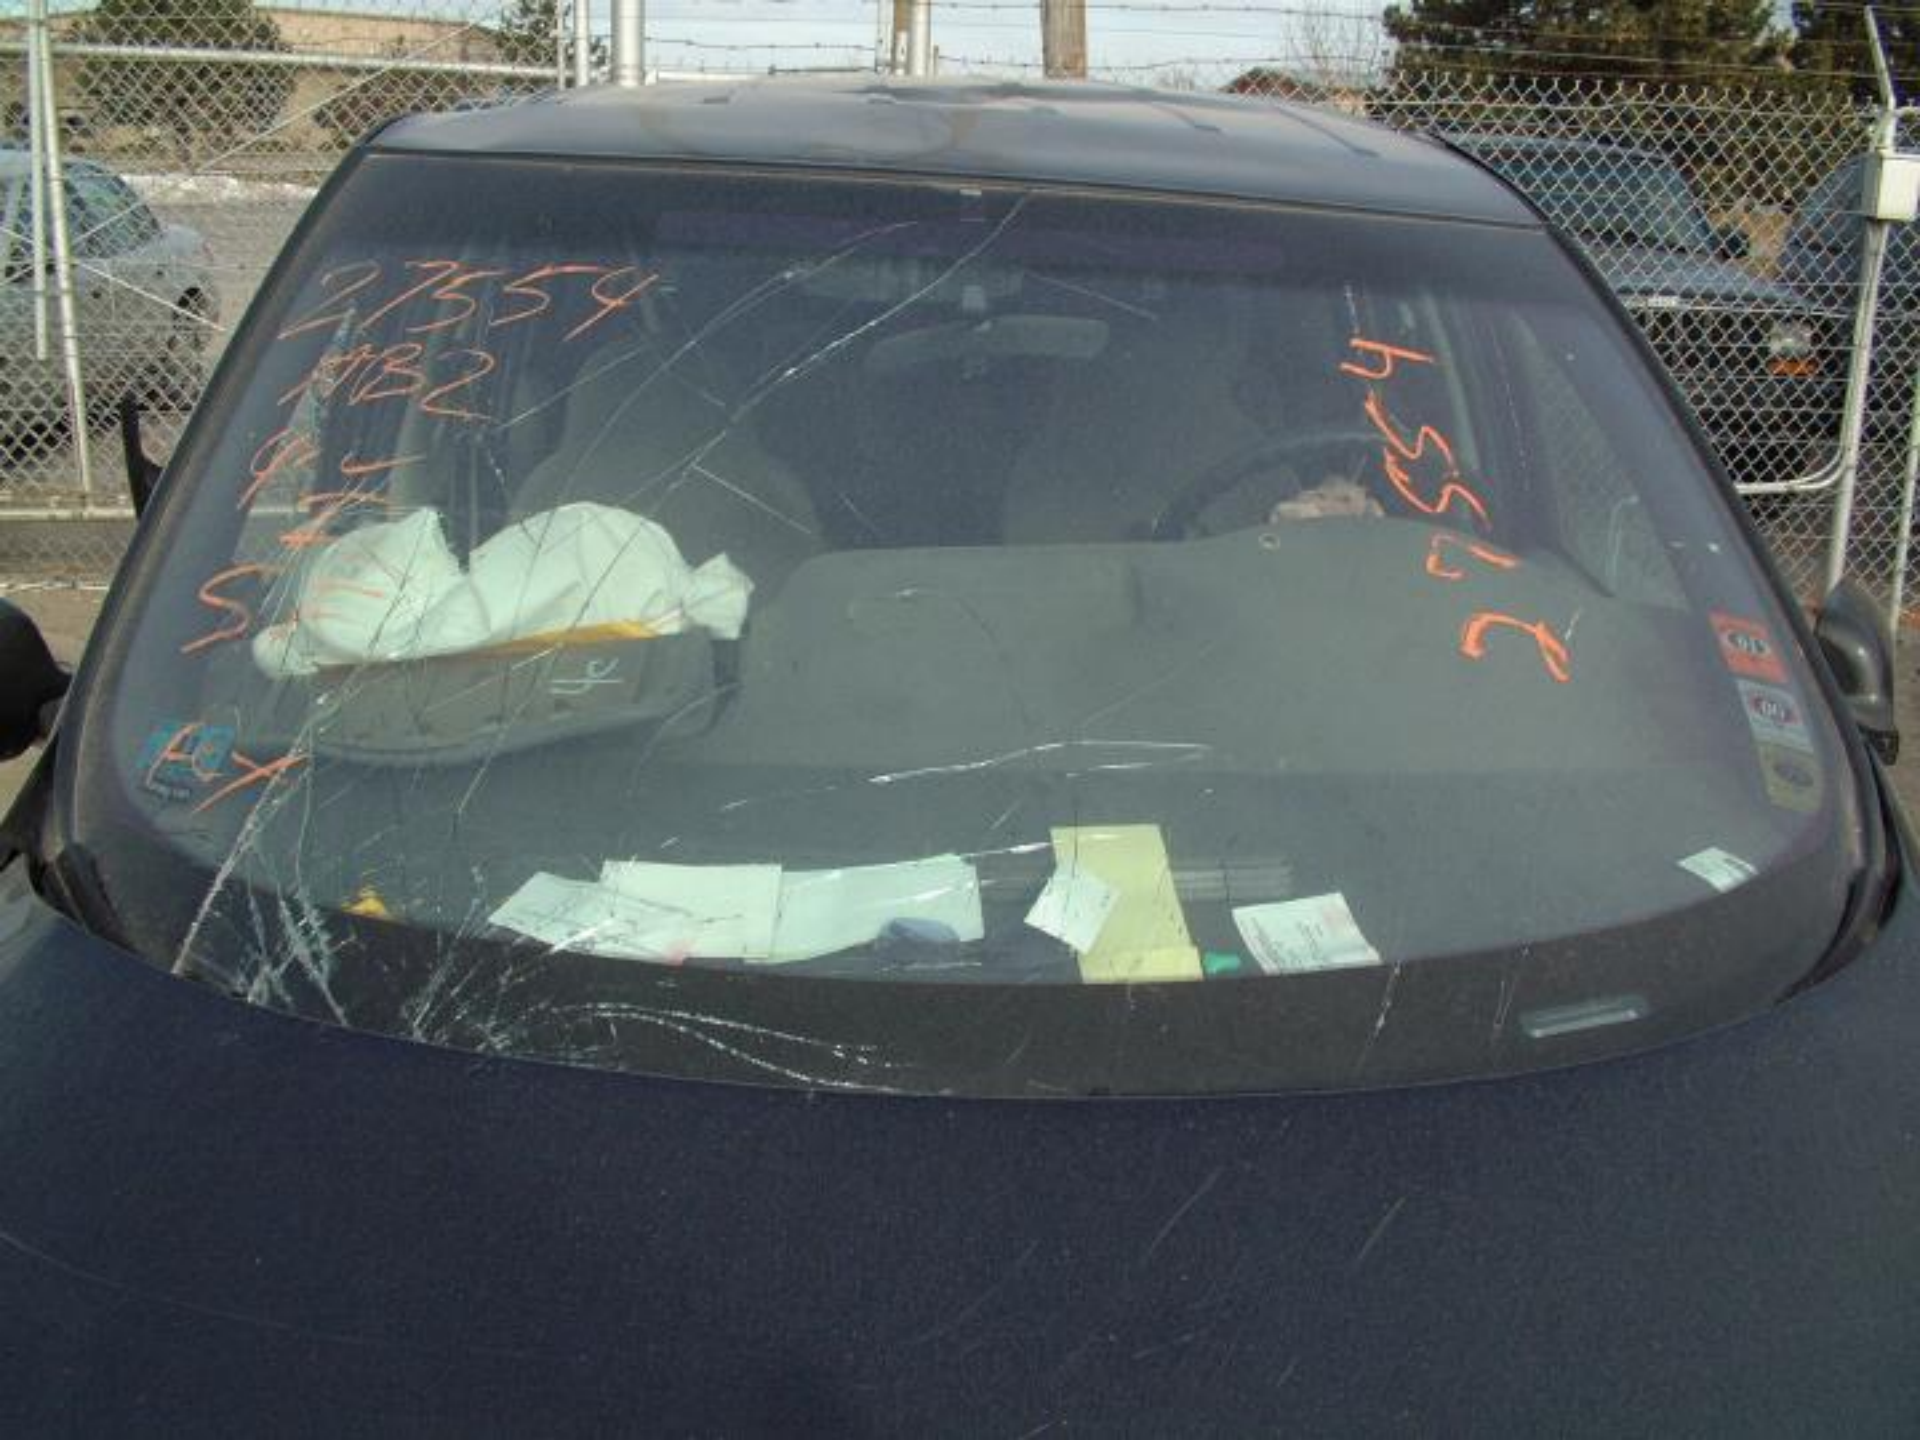
This vehicle was equipped with steering-wheel and dash-mounted frontal-impact airbags and [32](#) [33](#) [34](#) [35](#) both deployed in the frontal impact. [36](#) The front seats of this vehicle were also equipped with seatback-mounted side-impact airbags but neither airbag deployed. In the driver area, [37](#) [38](#) [39](#) [40](#) there was no damage to the steering-wheel airbag or to the flaps of the airbag module cover. There [41](#) [42](#) [43](#) was also no damage to, or deformation of, the steering-wheel rim or spokes, and there was no deflection of the steering column. [44](#) The plastic cover of the driver knee bolster was scuffed to the left of the steering column, [45](#) the floor pan was buckled, and the gas and brake pedals were deflected to the right. [46](#) [47](#) The forward portion of the driver seat cushion was displaced down, the driver seat was leaning to the right, and the seat adjuster was jammed in a mid-track position. [48](#) There was no other damage to the interior in the driver area.

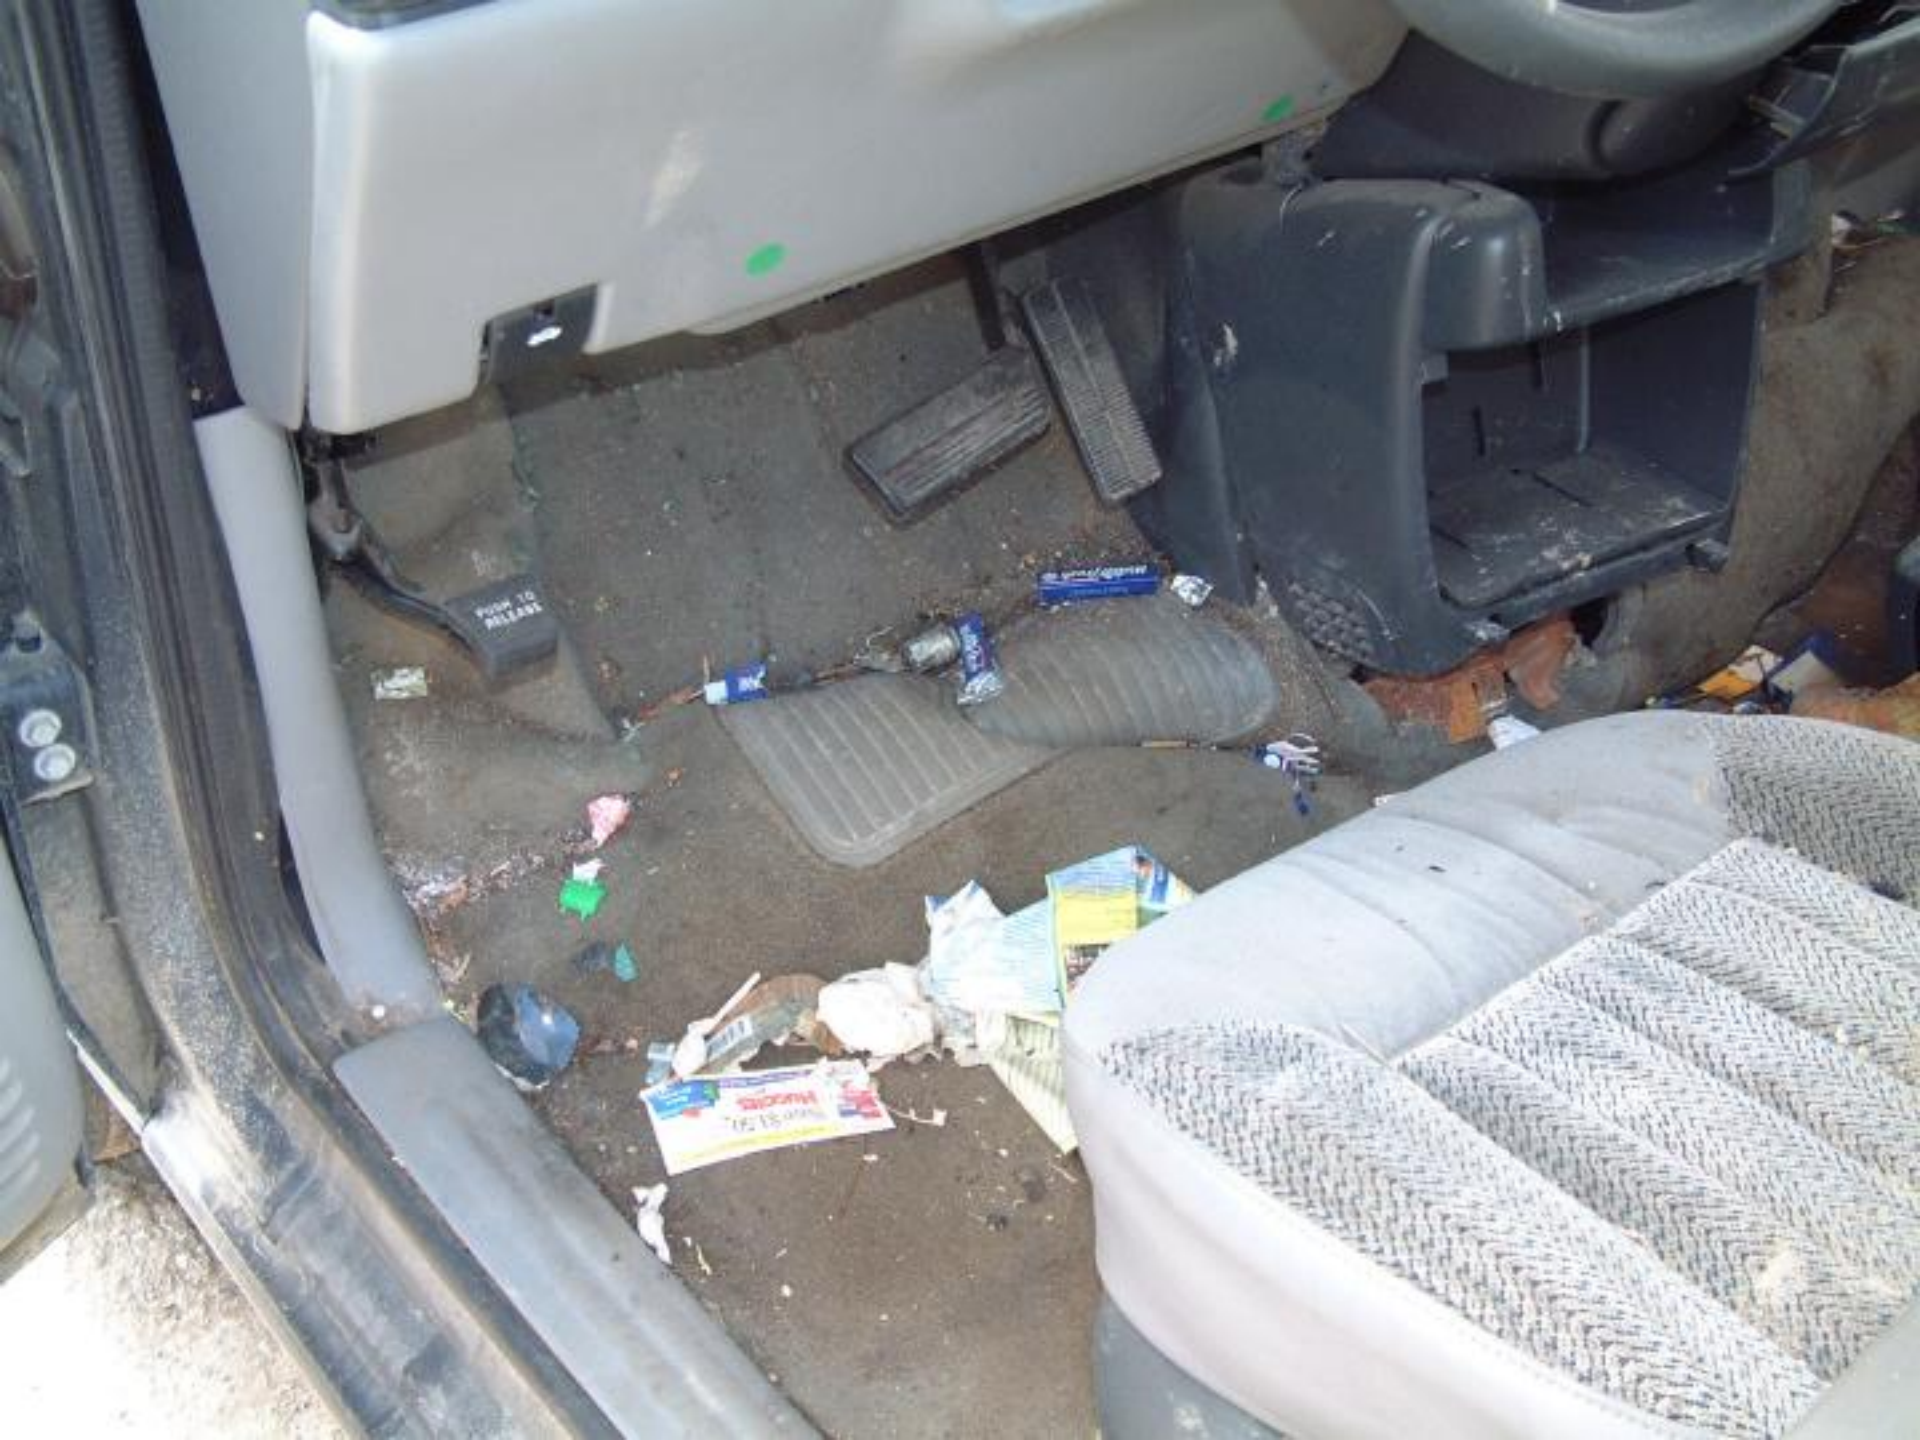
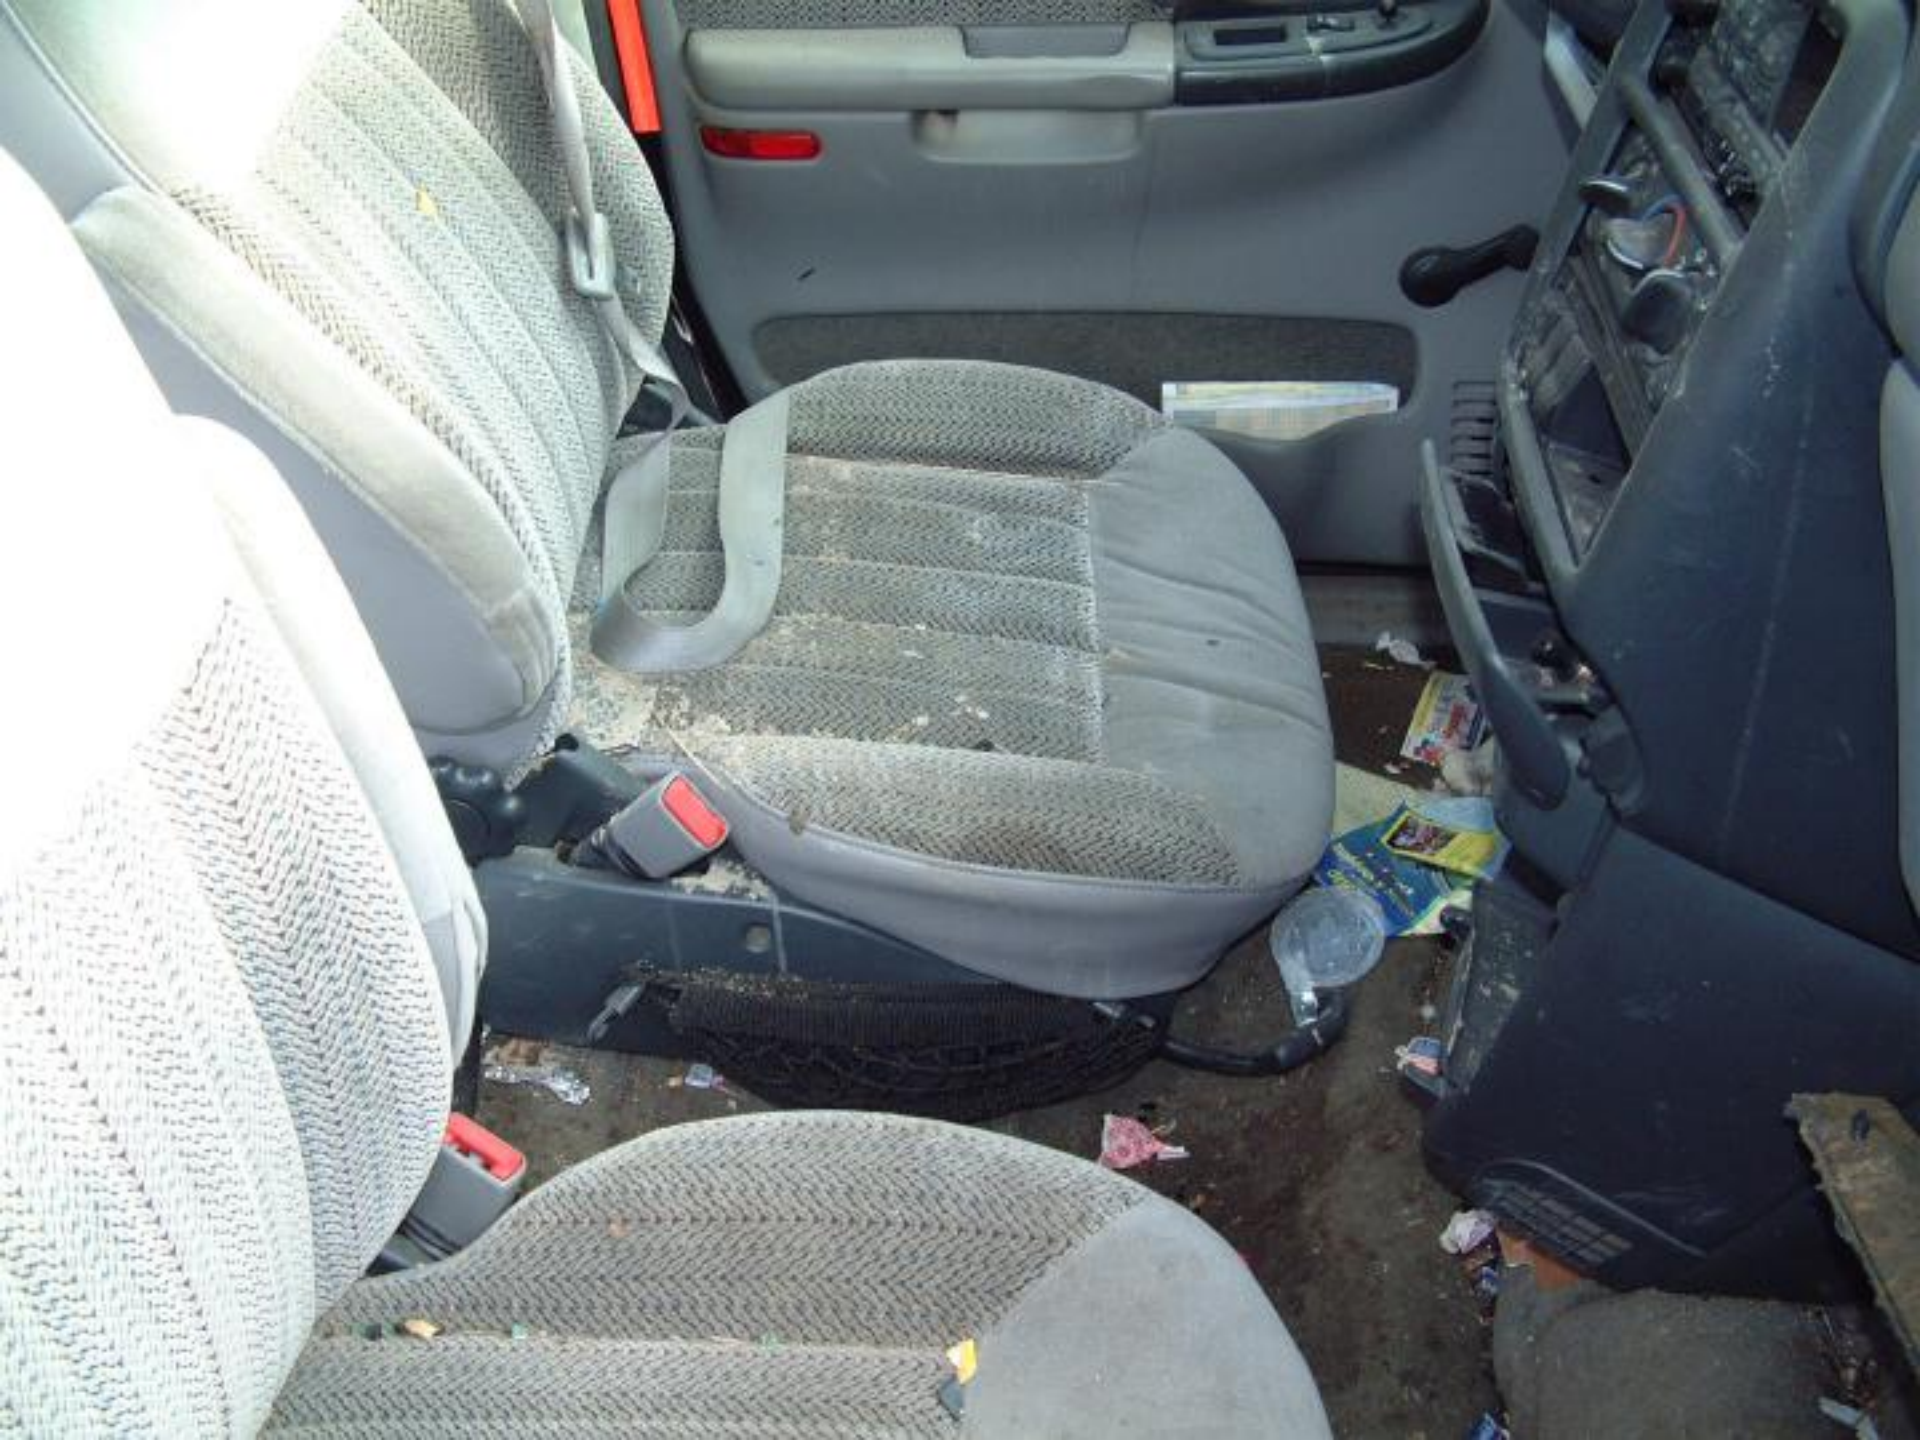
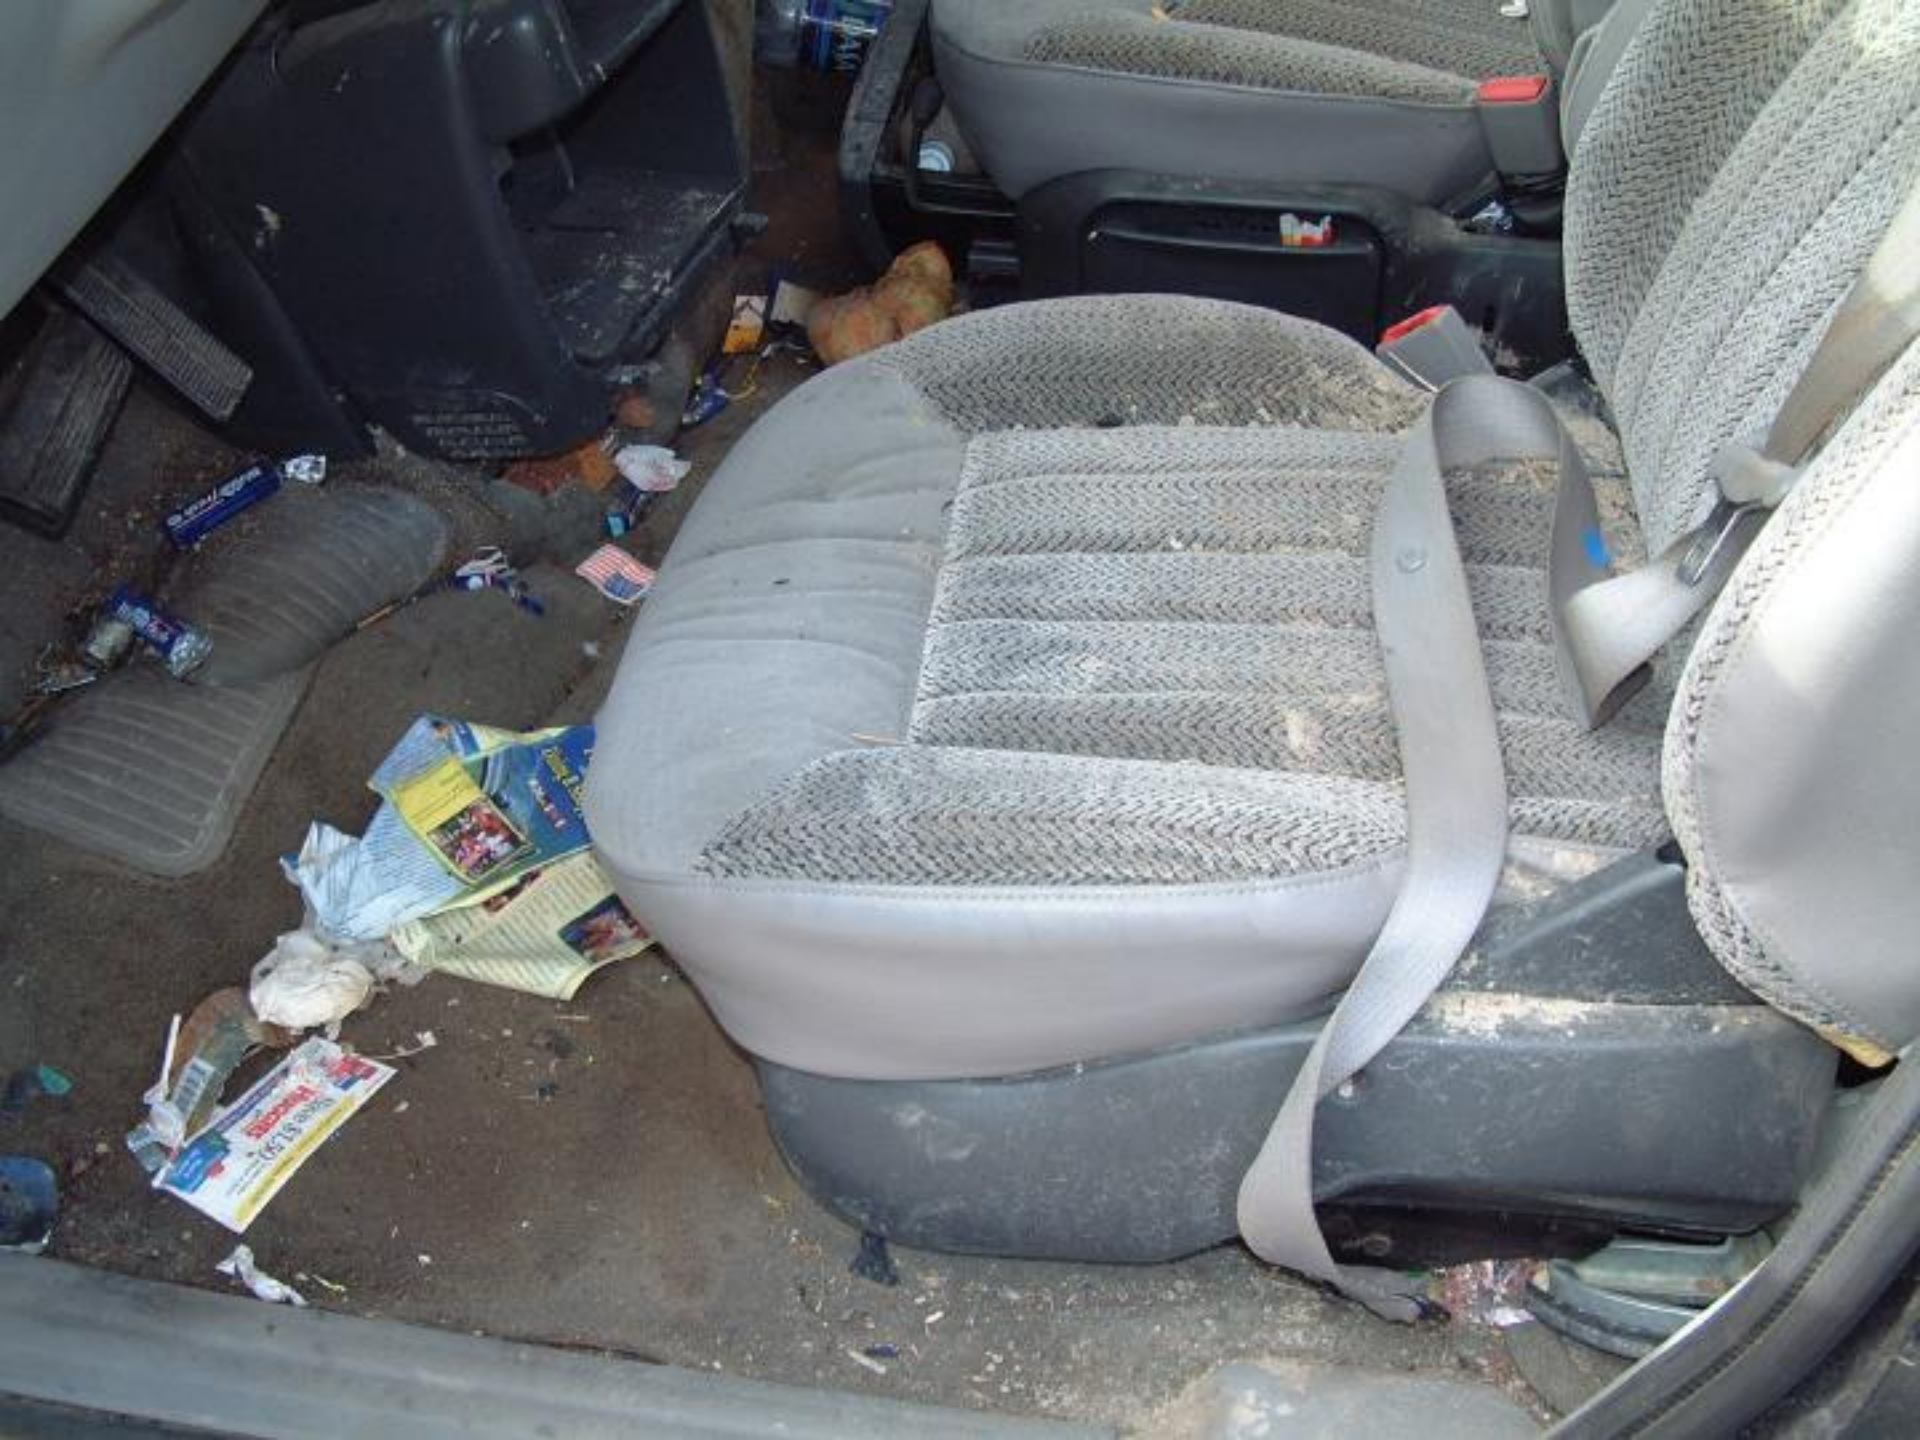
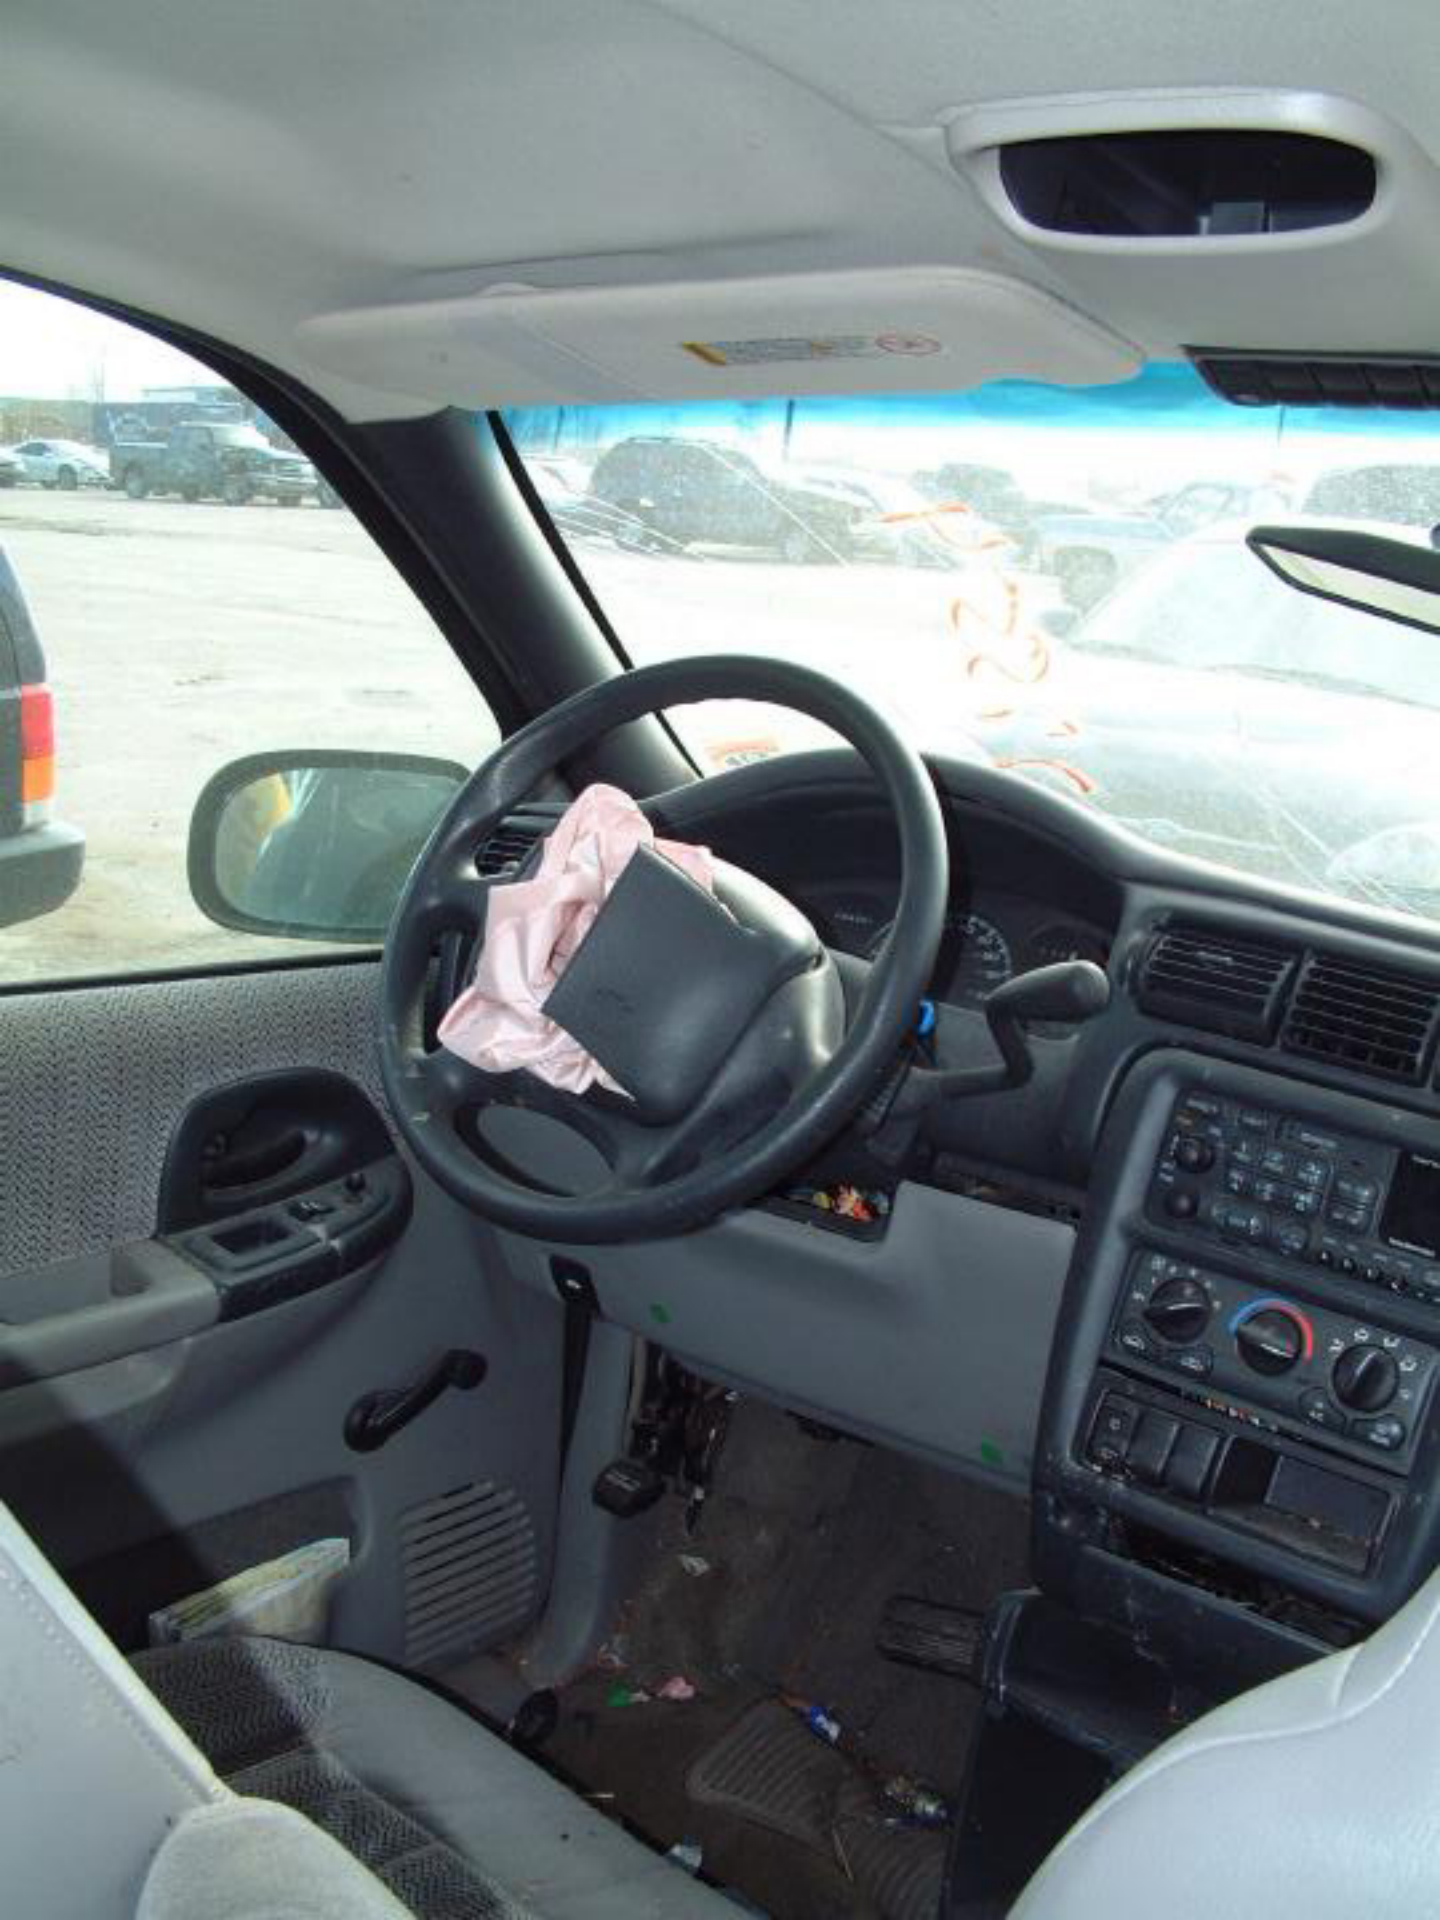
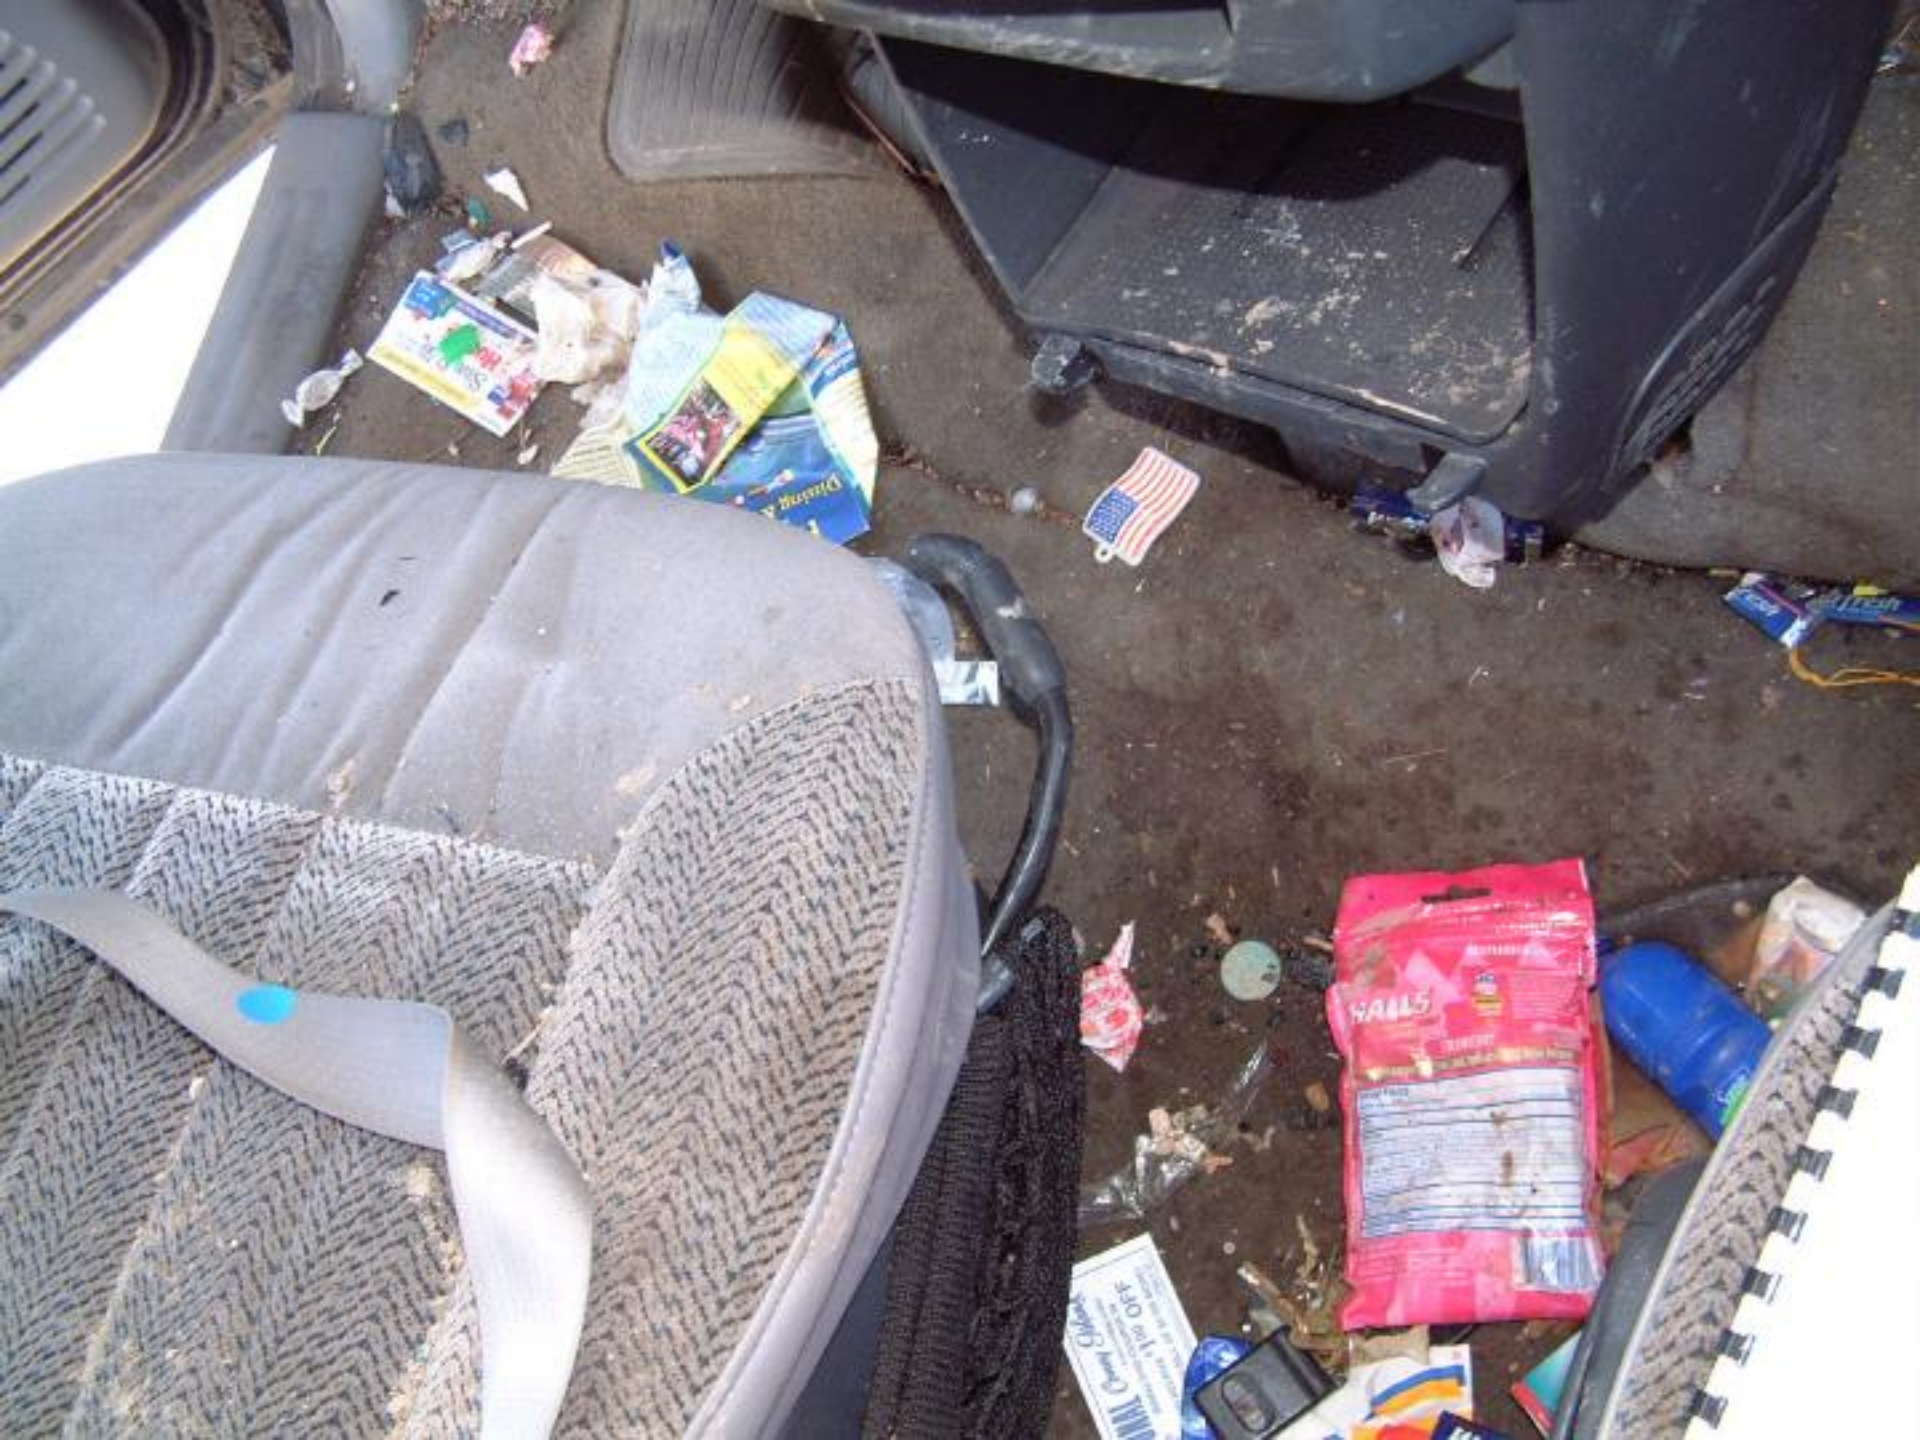
Location	Component	Distance (cm)	Direction
Driver	Floor 57	12	up
	Toe pan 58	10	to rear
Right front	Toe pan 59	27	to rear
	Floor 60	22	up
	Instrument panel 61	4	to rear
